LUXURIOUS VILLA, MYKONOS, GREECE

Roof Waterproofing System: Coating Sikalastic®-612, Sika® Reemat Premium

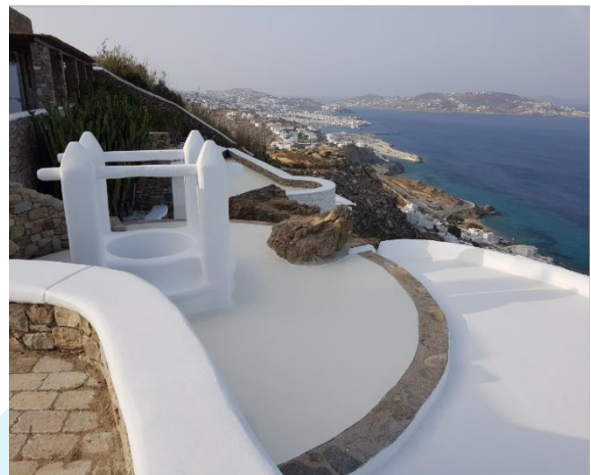
The existing waterproofing layer (acrylic membrane) of the surrounding area of the villa has failed. The new system should exhibit high resistance to ultraviolet radiation and atmospheric chemicals - common stresses in Cycladic islands. Moreover, due to the original architecture on the islands, the aesthetics of the residence and the requirement of its harmonization with the surrounding area, the final shade of the horizontal surface of the roof hat to be highly white to match the aesthetics of the houses in the Aegean Sea.
